TEST REPORT

No. : NBIN2012015060SC

Sample Name : ELECTRIAL INSULATING TAPE

Test Item: Low Temperature Resistance Test

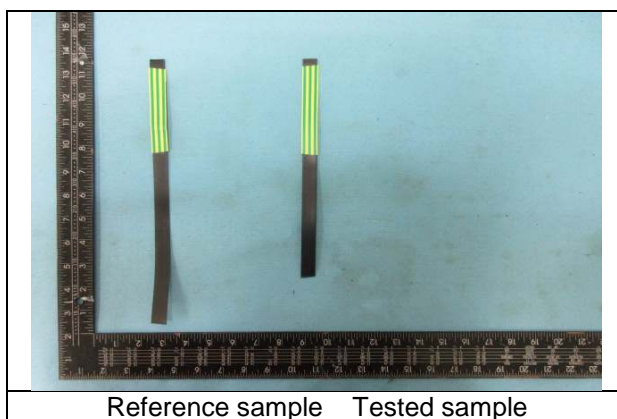
Test Photo:

Test Method: Provided by client, place the sample in the chamber under the specific condition, then check the sample after test.

Test Condition: -55°C, 8h

Test Item	Appearance
Low Temperature Resistance Test	The tape did not fall off.
