TEST REPORT

No. : NBIN2011014577SC

Sample Name : PVC COATED STAINLESS STEEL CABLE TIE

Product Specification : STB series

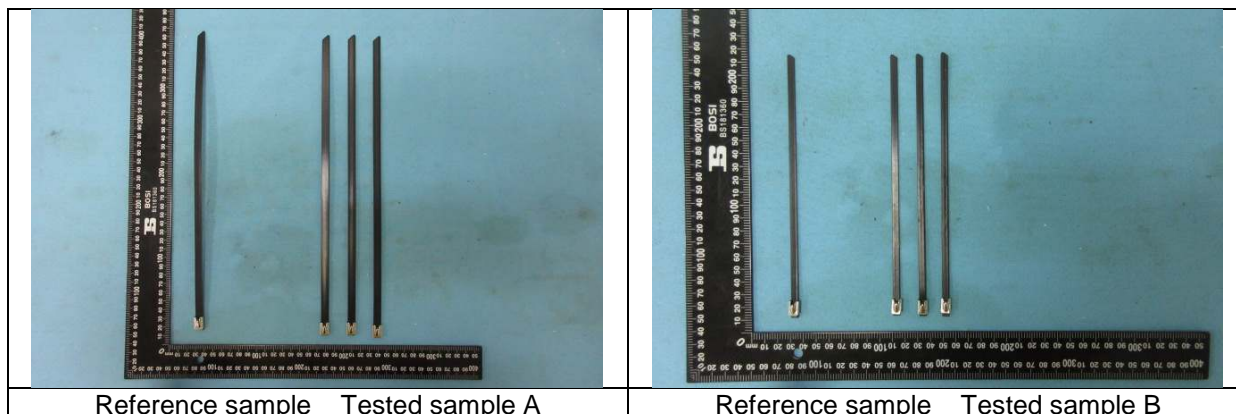
Test Photo:

Test Method: Provided by client, place the sample in the chamber with the specific condition, then check the sample after test.

Test Condition: -60℃, 8h

Test Item	Sample	Appearance
Low Temperature Resistance Test	A	No visible change.
	B	No visible change.

Reference sample Tested sample A Reference sample Tested sample B
